Subject: 301 Mission Retrofit Supplemental Monitoring Report 069: Results as of August 31, 2022

Millennium Tower Perimeter Pile Upgrade: Instrumentation Monitoring Data
City and County of San Francisco, California

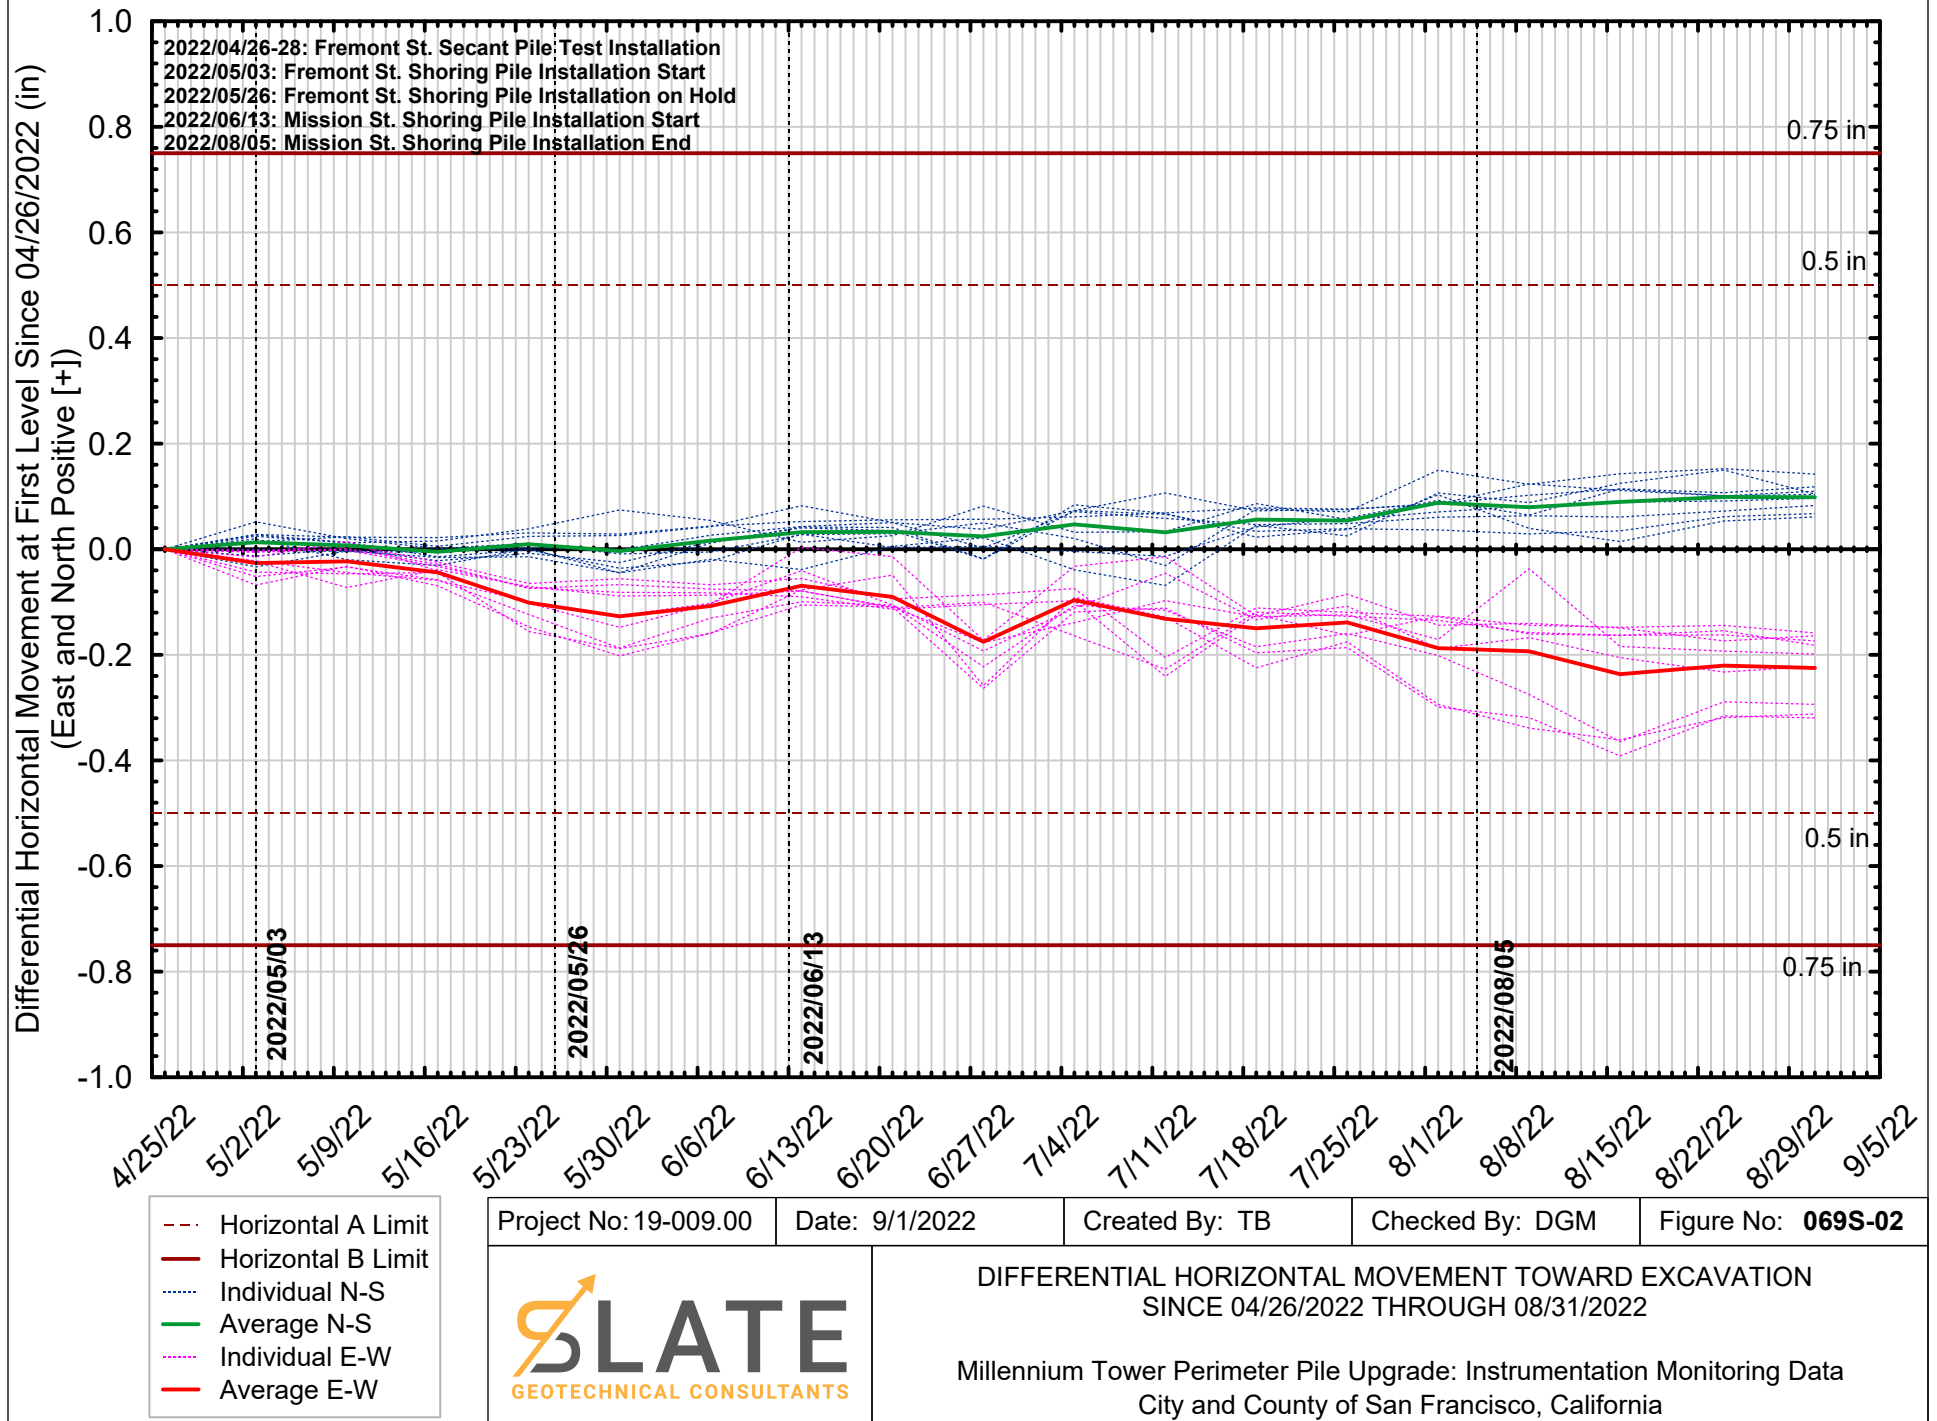
Figure S-02 – Differential Horizontal Movement Toward Excavation Since 04/26/2022 through 08/31/2022

Figure S-02 presents the differential horizontal movement toward the excavation at survey prisms installed at approximately one floor level above grade on the exterior of the building, as well as the average in each of the project north-south and east-west direction, since April 26, 2022, through August 31, 2022. Limits established in the aforementioned letter are included for reference.

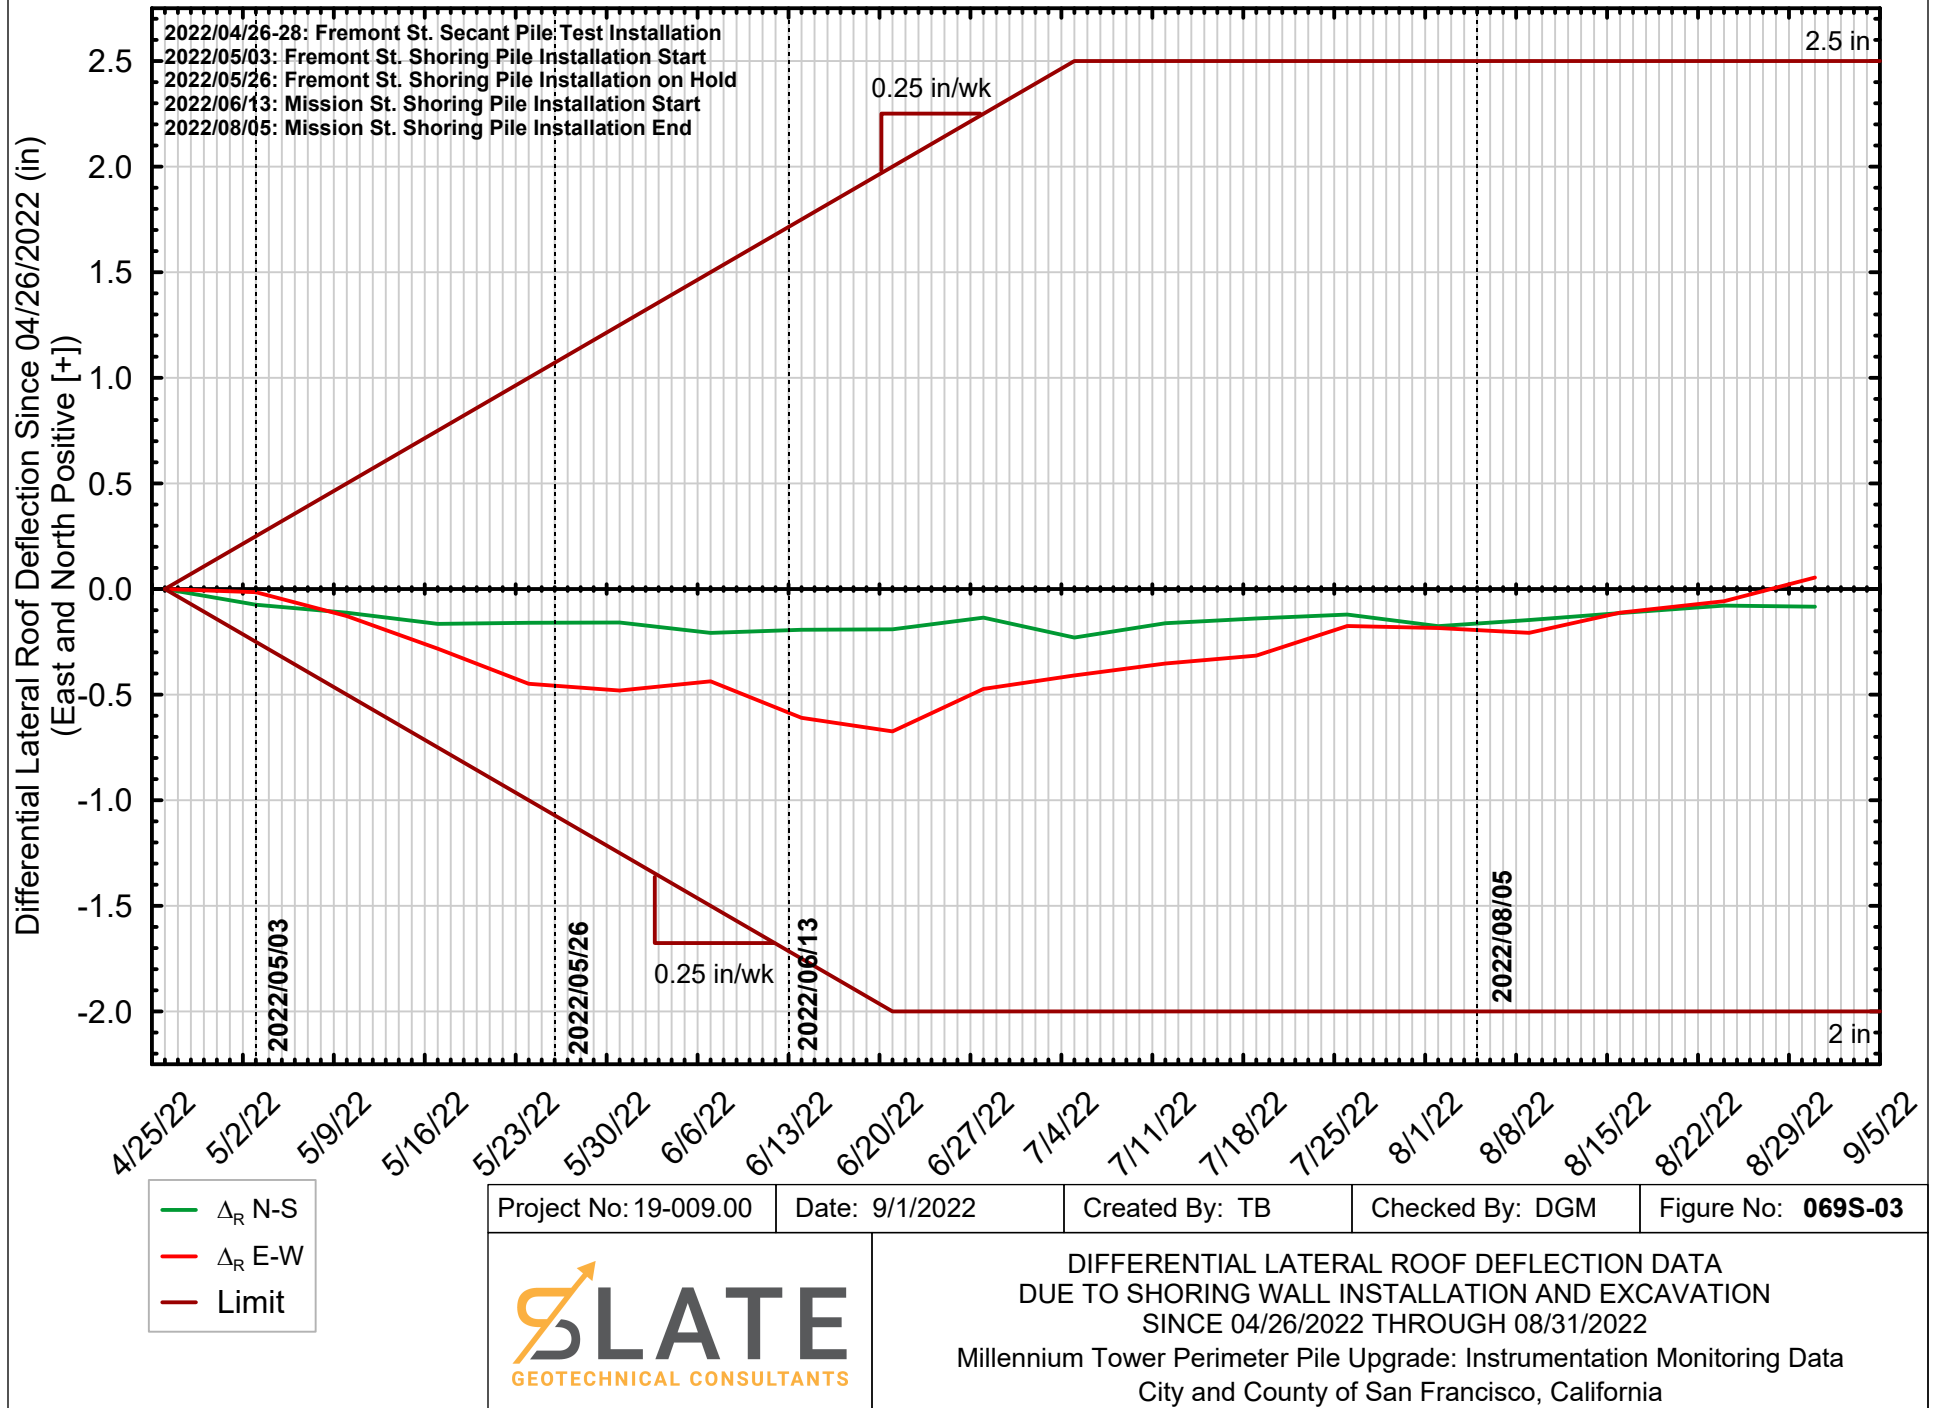
Figure S-03 – Differential Lateral Roof Deflection Data due to Shoring Wall Installation and Excavation since 04/26/2022 through 08/31/2022

Figure S-03 presents differential lateral roof deflection data due to shoring wall installation and excavation since April 26, 2022, through August 31, 2022. Limits established in the aforementioned letter are included for reference. Note that differential lateral roof deflection due to shoring wall installation and excavation is calculated following the aforementioned letter as:

$$\Delta_R = \Delta_{R-prism} - \Delta_H - \alpha T$$

where: Δ_R is the computed differential lateral roof deflection due to shoring wall installation and excavation;
 $\Delta_{R-prism}$ is the differential lateral roof deflection obtained from prism data;
 Δ_H is the average differential horizontal movement "at-grade";
 α is the weekly lateral roof deflection rate (computed as described below); and,
 T is the number of weeks since initiation of shoring wall installation or excavation.

The time frame over which α is computed changes depending on the phase of the work, as specified in the aforementioned letter. For the construction phase during which the shoring wall is installed (currently ongoing), α is computed from the two months of monitoring conducted immediately prior to the shoring wall installation (i.e., monitoring data from February 22, 2022, through April 25, 2022). During the excavation phase (to occur in the future), α will be readjusted to reflect the recorded lateral roof deflection rate in the two months immediately preceding the start of excavation (dates to be determined).

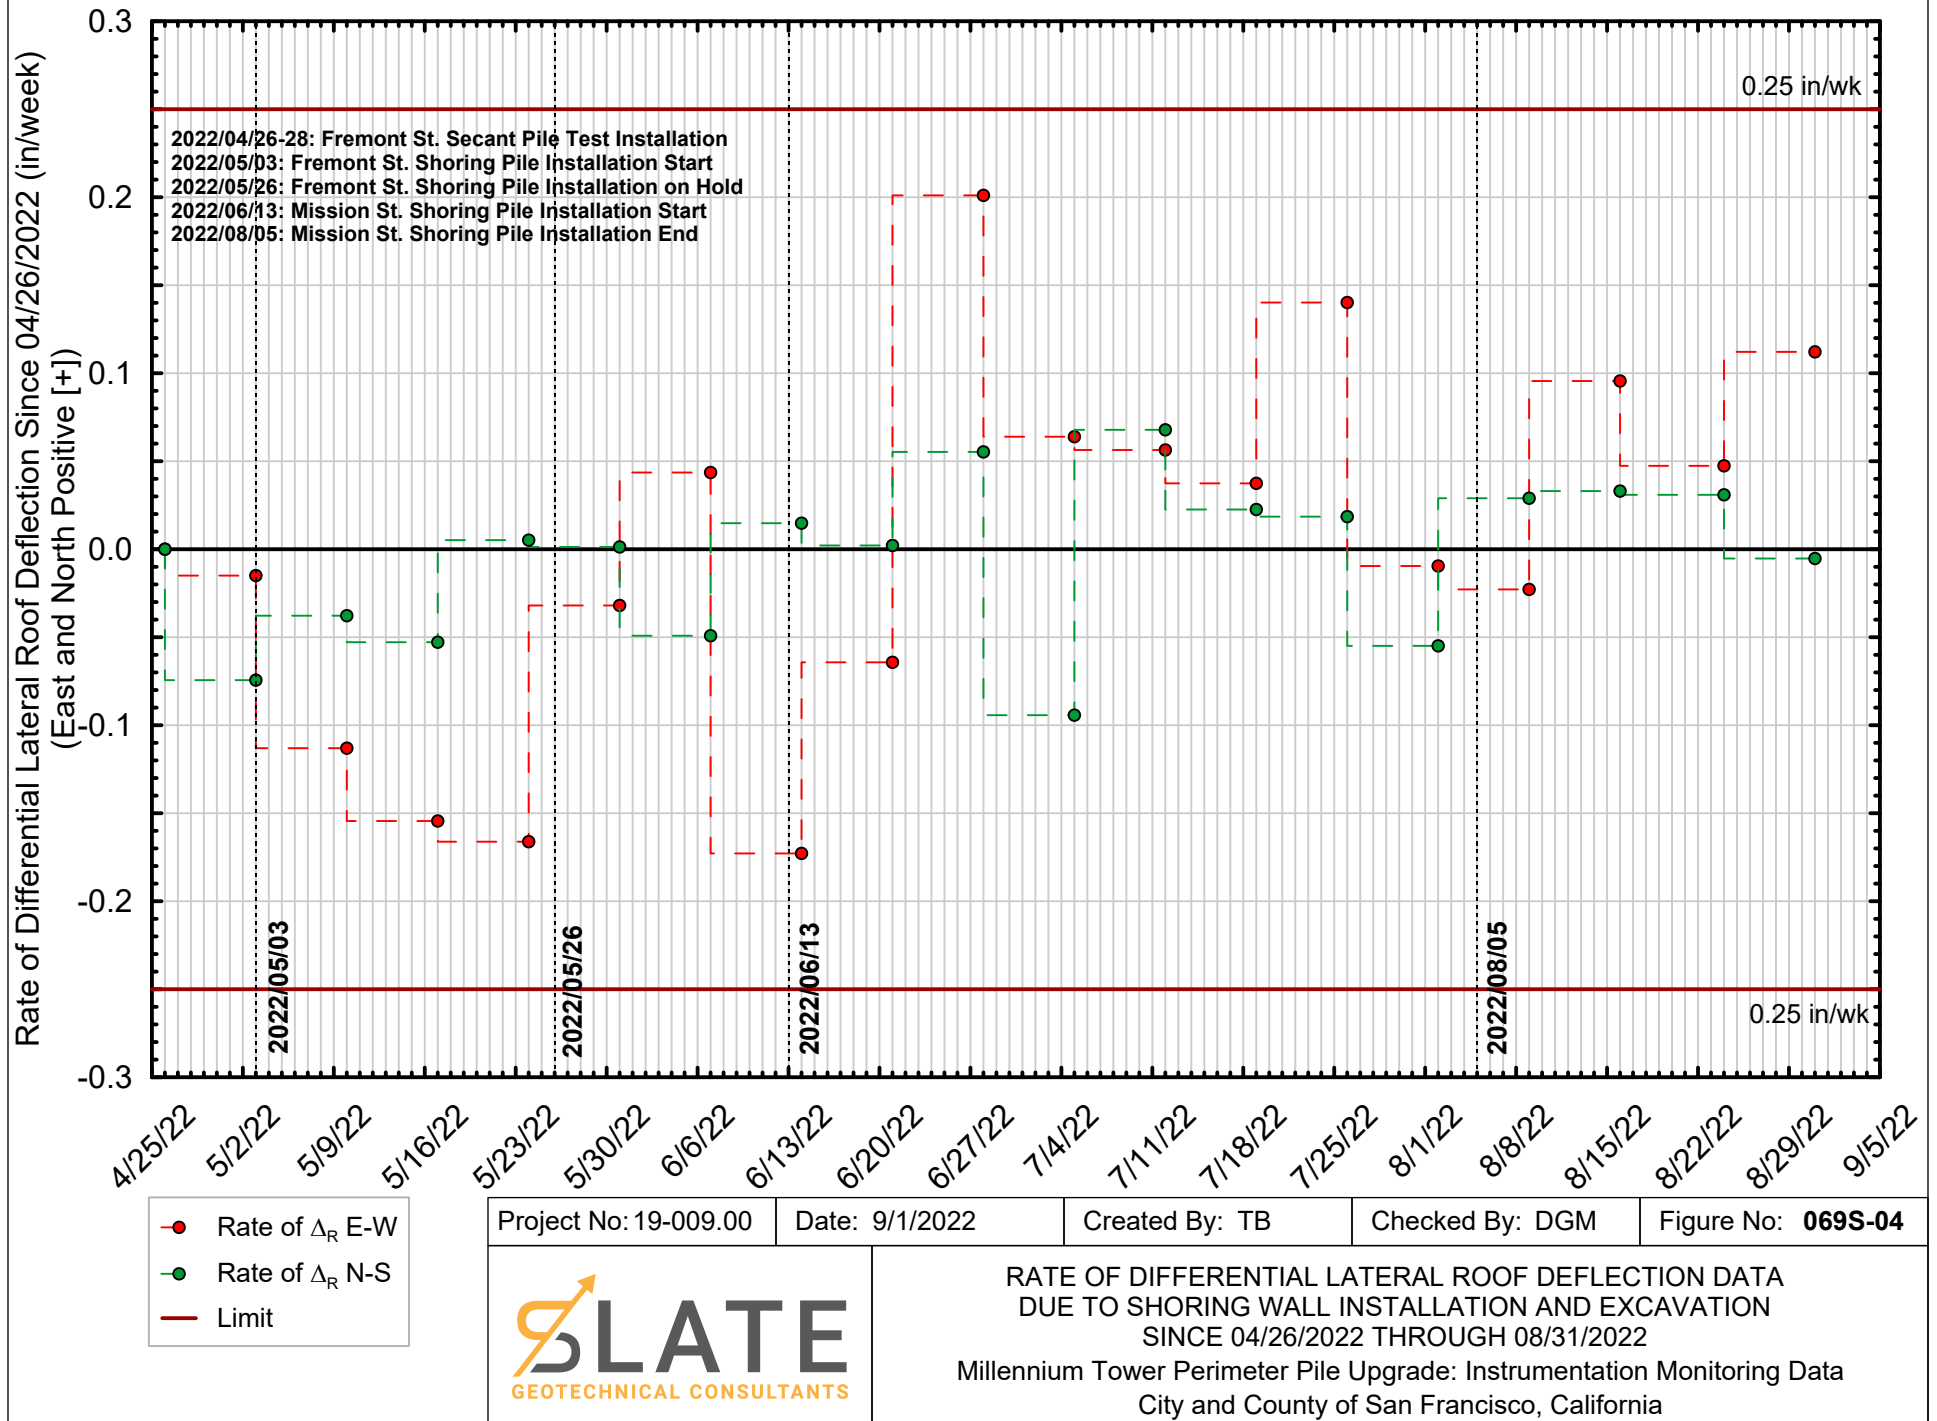
Figure S-04 – Rate of Differential Lateral Roof Deflection Data due to Shoring Wall Installation and Excavation since 04/26/2022 through 08/31/2022

Figure S-04 presents rates of differential lateral roof deflection data due to shoring wall installation and excavation since April 26, 2022, through August 31, 2022. Limits established in the aforementioned letter are included for reference. Note that the rates are calculated as:

$$\frac{d\Delta_R}{dT} \approx \frac{\Delta_{R,t} - \Delta_{R,t-1}}{T_t - T_{t-1}}$$

where: t is an index representing the current instance in time; and
 $t - 1$ is an index representing the previous instance in time.
